LOUISIANA DEPARTMENT OF WILDLIFE AND FISHERIES

2021 AQUATIC VEGETATION CONTROL PLAN

CHICOT LAKE

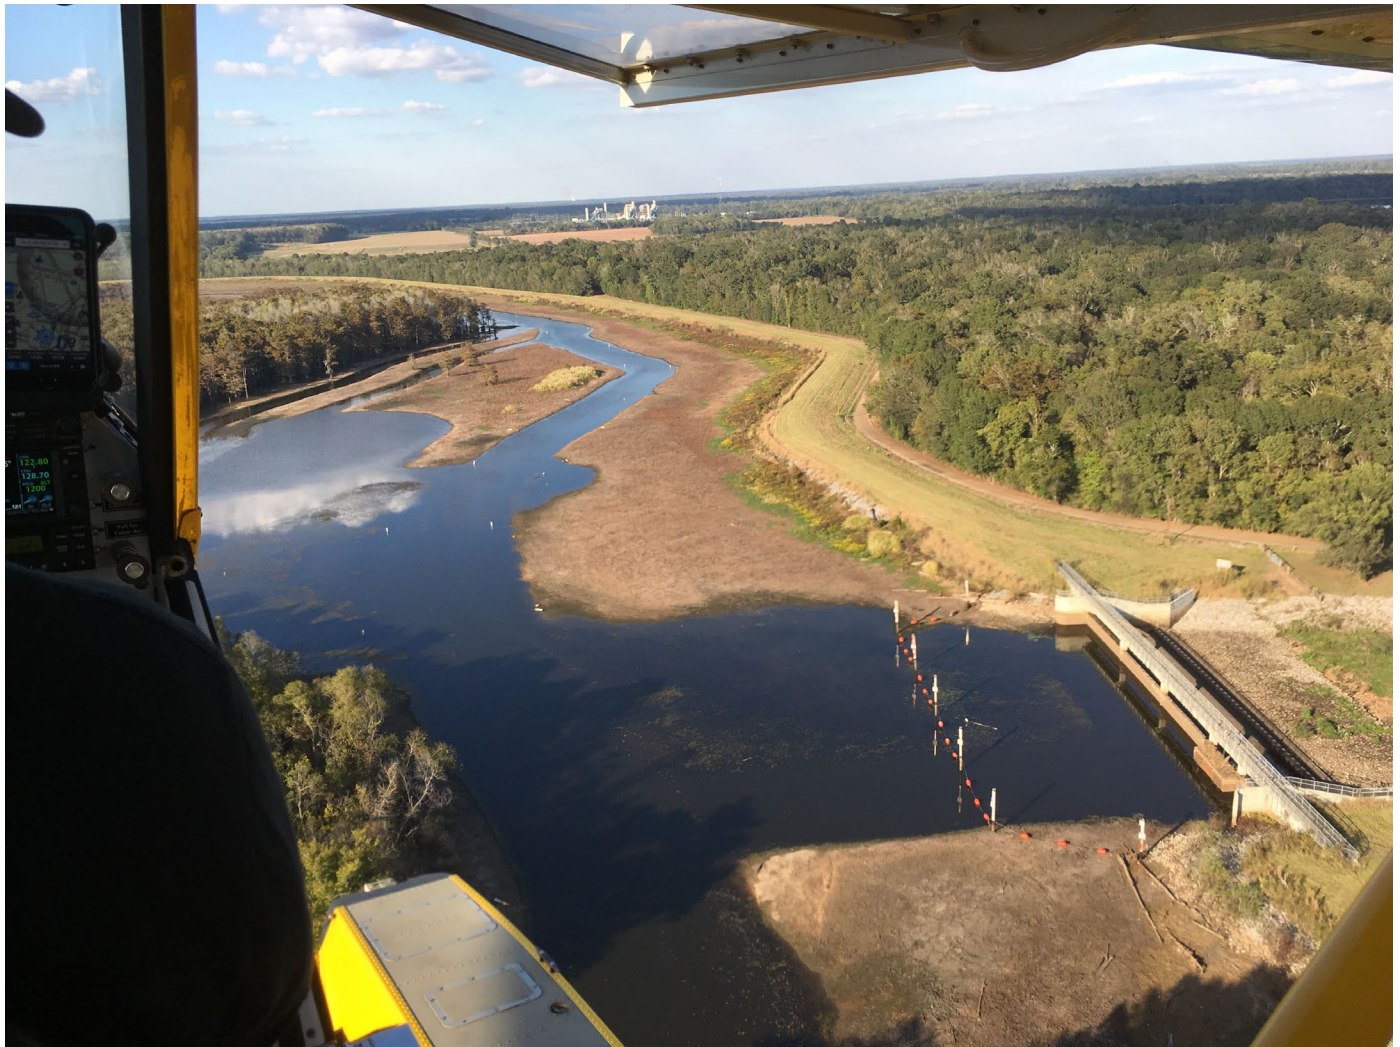
Aerial photo of Chicot Lake drawdown – October 2016

A drawdown was conducted in 2016. The control structures were opened on September 12, 2016 to allow dewatering at a rate of 2-3 inches per day. The control structures were closed on October 3, 2016, and all boating activity was prohibited due to unsafe boating access. The Louisiana Department of Transportation and Development (DOTD) needed to replace a number of support pilings, and the lake was drawn down approximately 5-6 feet for these repairs. This DOTD drawdown coincided with a Louisiana Department of Wildlife and Fisheries (LDWF) recommended drawdown to control aquatic vegetation. Water level fluctuation is an important tool for lake management. Drawdowns mimic natural low water periods of the fall, can provide many of the same benefits including aquatic vegetation control, and improved fish habitat. In addition, exposure to air is critical for decomposition of organic materials on the lake bottom. The re-flooded habitat is an improved and more productive spawning substrate for nesting fish.

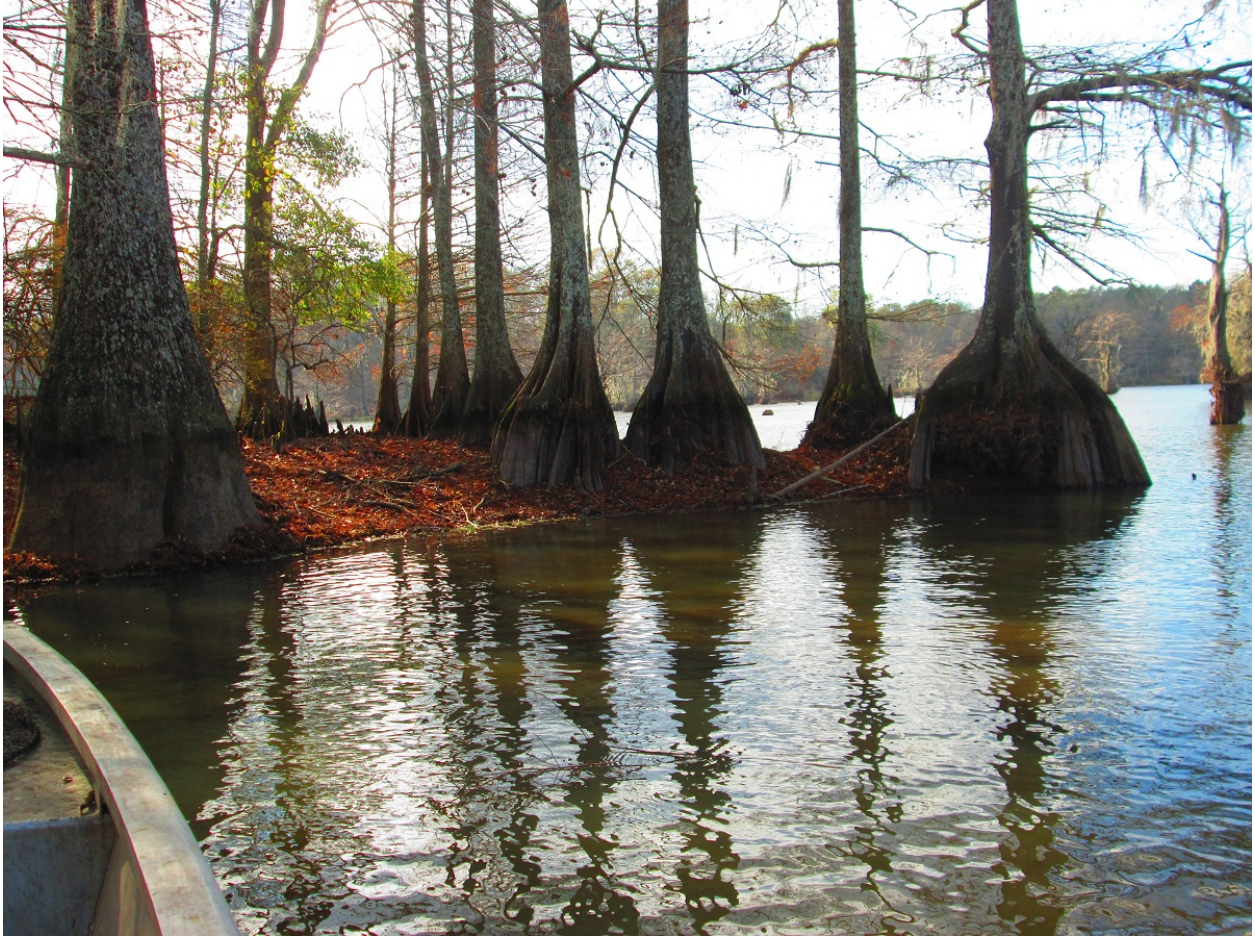
Photo of Chicot Lake drawdown – December 2019

Cooler fall water temperatures reduce the potential for fish kills. Therefore, the control structure was opened September 9, 2019 allowing the water level to recede 3.0 inches per day. The control structure was closed when three feet below pool stage was reached. The target water level was maintained in early January 2020. The lake remained open to fishing and other recreational activities.

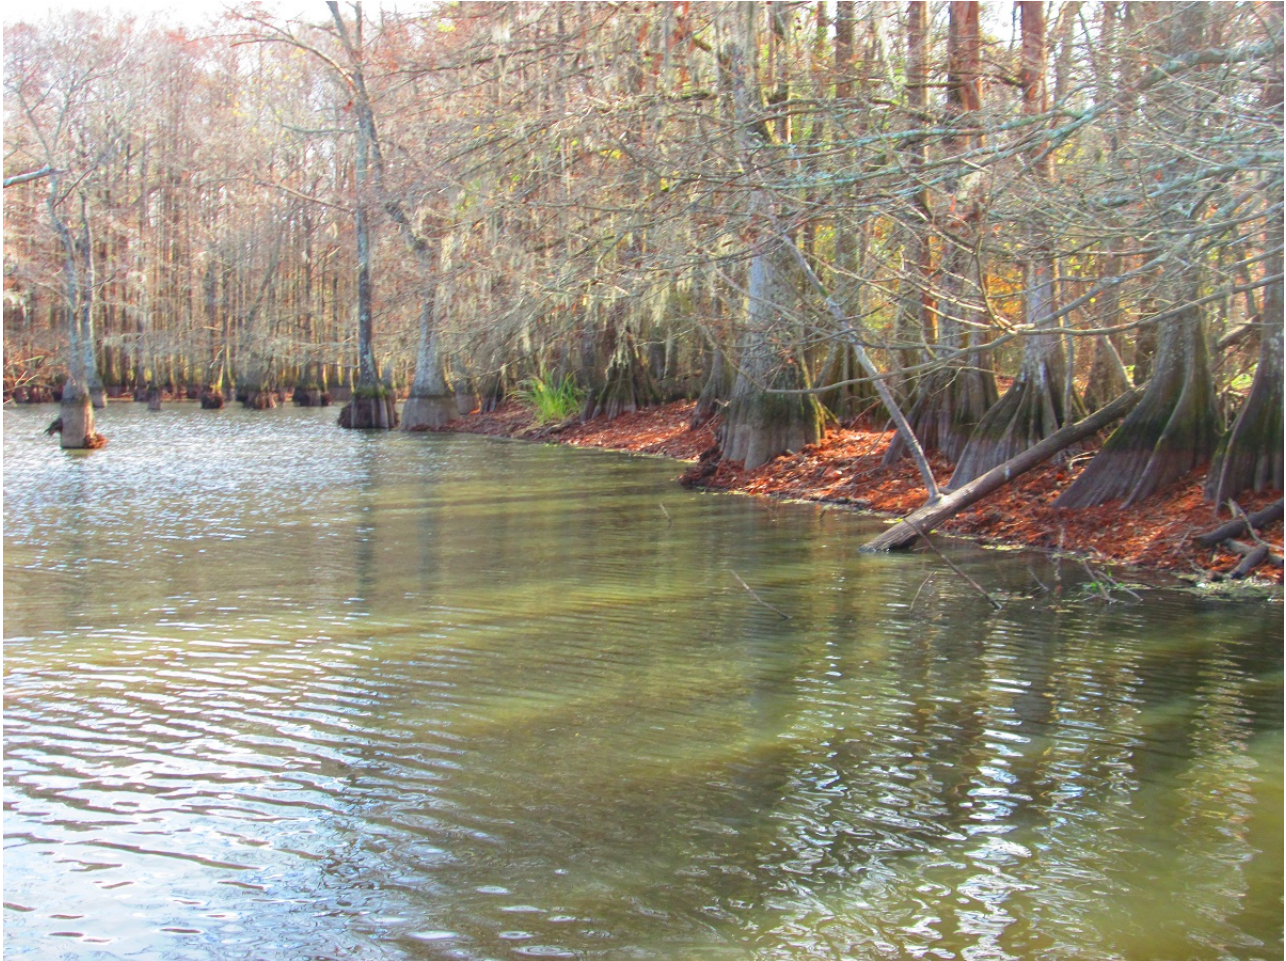
Photo of Chicot Lake drawdown – December 2019
